Approval: \_\_\_\_\_  
Date: 1-29-2017  
Checked: JLD  
Drawn: \_\_\_\_\_  
Scale: 1"=200'  
Project Number: 16-4005  
Sheet: C-3

PROJECT: SOUTH GREENVILLE POINT REPAIR PROJECT  
SHEET TITLE: POINT REPAIR 1 - 3

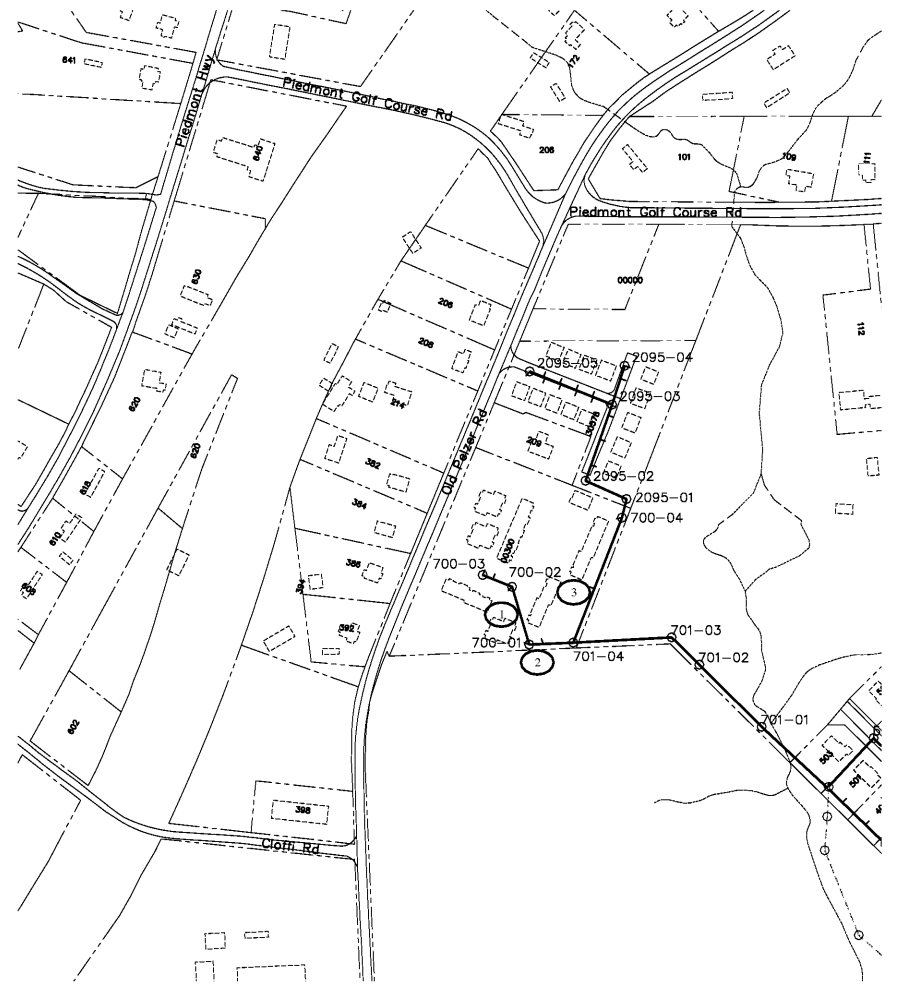
Point Repair #	Start MH	End MH	Start MH Depth (ft)	End MH Depth (ft)	Total Length of Pipe (ft)	Pipe Diameter (in)	Location from Start MH (ft)	Pipe Material	Problem Summary	Service Position	Pre-CIPP	Repair	Repair Detail	Patch Detail
1	700-02	700-01	7.1	8.1	132.7	8	123.8	PVC	Offset Joint - Medium			Repair (118.8 FT to 136.4 FT)	5	
2	700-01	701-04	8.1	6.4	99.0	8	8.0	PVC	Pipe Sag - 50%			Pt. Repair (0.0 FT to 8.0 FT)	5	
3	700-04	701-04	4.0	6.4	294.5	8	173.5	PVC	Service - Roots at Tee and Lateral			Pt. Repair (68.5 FT to 138.5 FT) - Install Tee and Lateral	2, 3, & 7
