SOUTH GREENVILLE  
POINT REPAIR PROJECT

POINT REPAIR 72 - 85

Project Number: 16-4005

Sheet: C-10

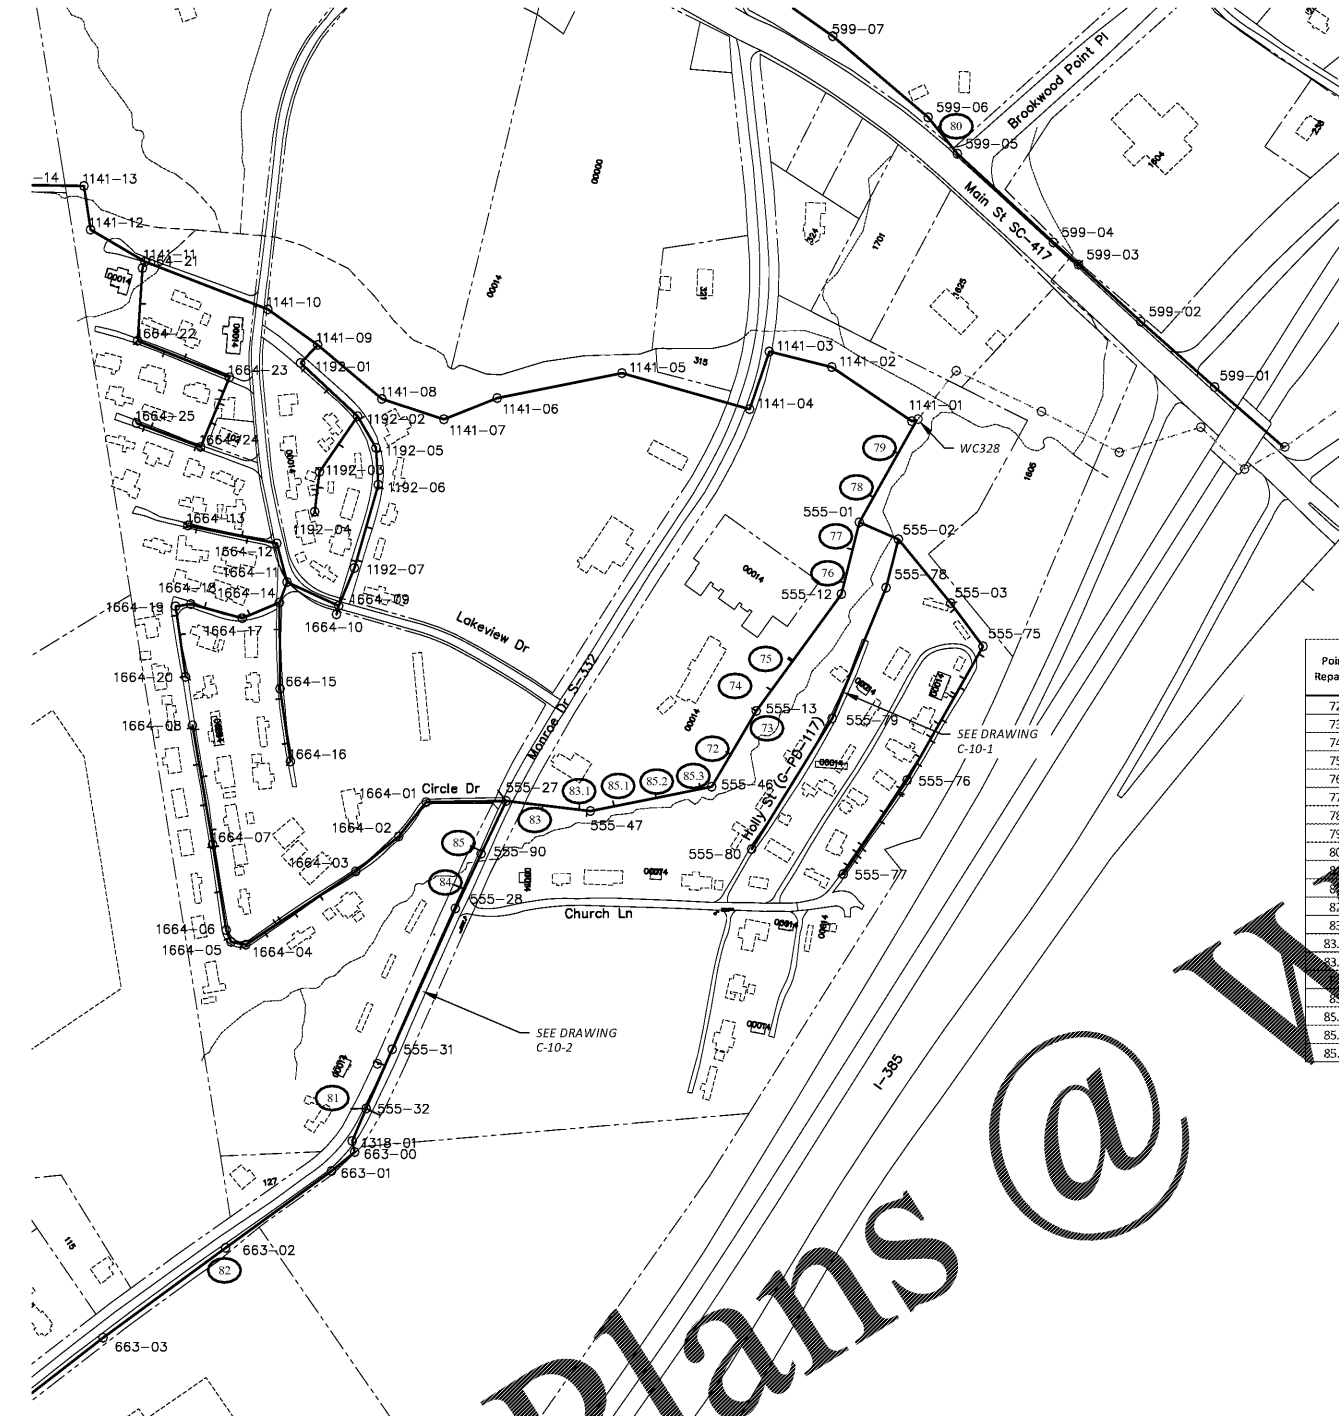
Point Repair #	Start MH	End MH	Start MH Depth (ft)	End MH Depth (ft)	Total Length of Pipe (ft)	Pipe Diameter (in)	Location from Start MH (ft)	Pipe Material	Problem Summary	Service Position	Pre-CIPP	Repair	Repair Detail	Patch Detail
72	555-46	555-13	8.5	6.4	105.2	8	85.3	VCP	Service - Roots at Tee and Lateral	9	*	Pt. Repair (80.3 FT to 90.3 FT) - Install Tee and Lateral	2,3, & 7	
73	555-13	SERV 3	6.4	6.4	321.1	6	5.0	PVC	Deformed	9	*	Replace to ROW	15	
74	555-13	555-12	6.4	6.4	321.1	6	58.4	VCP	Service - Roots at Tee and Lateral	9	*	Pt. Repair (53.4 FT to 63.4 FT) - Install Tee and Lateral	2,3, & 7	
75	555-13	555-12	6.4	6.4	321.1	6	130.3	VCP	Service - Protruding into Mainline	9	*	Pt. Repair (125.3 FT to 135.3 FT) - Install Tee	3	
76	555-12	555-01	6.7	6.0	142.6	8	27.9	VCP	Service - Roots at Tee and Lateral	9	*	Pt. Repair (22.9 FT to 32.9 FT) - Install Tee and Lateral	2,3, & 7	
77	555-12	555-01	6.7	6.0	142.6	8	226.3	VCP	Service - Roots at Tee and Lateral	10	*	Pt. Repair (121.3 FT to 131.3 FT) - Install Tee and Lateral	2,3, & 7

78	555-01	555-28	6.0	12.5	241.5	8	65.8	VCP	Service - Roots at Tee and Lateral	9	*	Pt. Repair (60.8 FT to 70.8 FT) - Install Tee and Lateral	2,3, & 7	
79	555-01	WC 328	6.0	12.5	241.5	8	179.7	VCP	Service - Roots at Tee and Lateral	9	*	Pt. Repair (174.7 FT to 184.7 FT) - Install Tee and Lateral	2,3, & 7	
80	555-06	SERV 3	7.7	3.6	105.2	8	32.4	PVC	Service - Lateral Offset	10		Pt. Repair (27.4 FT to 37.4 FT) - Install Tee and Lateral	2,3, & 7	10
81	555-28	SERV 3	11.7	6.4	192.7	8	16.8	VCP	4 x 6 Connection - Offset Joint at Connection			Replace to ROW	15	14
82	663-03	663-02	9.2	6.1	354.4	8	285.1	VCP	Offset Joint - Small			Pt. Repair (267.1 FT to 290.1 FT)	5	
83	663-03	663-02	9.2	6.1	354.4	8	272.1	VCP	Offset Joint - Medium			Pt. Repair (267.1 FT to 290.1 FT)	5	
83	555-27	555-47	11.7	6.4	192.7	8	83.9	VCP	Service - Roots at Tee and Lateral	3	*	Pt. Repair (78.9 FT to 88.9 FT) - Install Tee and Lateral	2,3, & 7

83.1	555-27	555-47	11.7	6.4	192.7	8	166.6	VCP	Service - Roots at Tee and Lateral	9	*	Pt. Repair (161.6 FT to 189.9 FT) - Install Tee and Lateral	2,3, & 7

83.1	555-27	555-47	11.7	6.4	192.7	8	184.9	VCP	Service - No Visible Defects	1	*	Pt. Repair (161.6 FT to 189.9 FT) - Install Tee	3	
84	555-28	555-90	10.8	10.8	130.9	8	48.3	VCP	Service - No Visible Defects	9	*	Pt. Repair (43.3 FT to 53.3 FT) - Install Tee and Lateral	2,3, & 7	14
85	555-90	555-27	10.8	11.7	145.8	8	5.4	VCP	Service - Debris	9	*	Pt. Repair (MH 11 to 10.0 FT) - Install Tee and Lateral	2,3, 4, & 7	14

85.1	555-47	555-46	6.4	8.5	301.1	8	55.5	VCP	Service - Roots at Tee and Lateral	9	*	Pt. Repair (50.5 FT to 60.5) - Install Tee and Lateral	2,3, & 7	
85.2	555-47	555-46	6.4	8.5	301.1	8	152.8	VCP	Service - Roots at Tee and Lateral	9	*	Pt. Repair (147.8 FT to 157.8 FT) - Install Tee and Lateral	2,3, & 7

85.3	555-47	555-46	6.4	8.5	301.1	8	255.7	VCP	Service - No Visible Defects	9	*	Pt. Repair (250.7 FT to 260.7 FT) - Install Tee and Lateral	2,3, & 7
