Norton Commons North - Apartments
 Prospect, Kentucky
 Bristol Development Group
 381 Mallory Station Rd, Suite 204
 Franklin, TN 37067

STRUCTURAL
 STANDARD
 POST TENSION
 DETAILS

SDT-7D

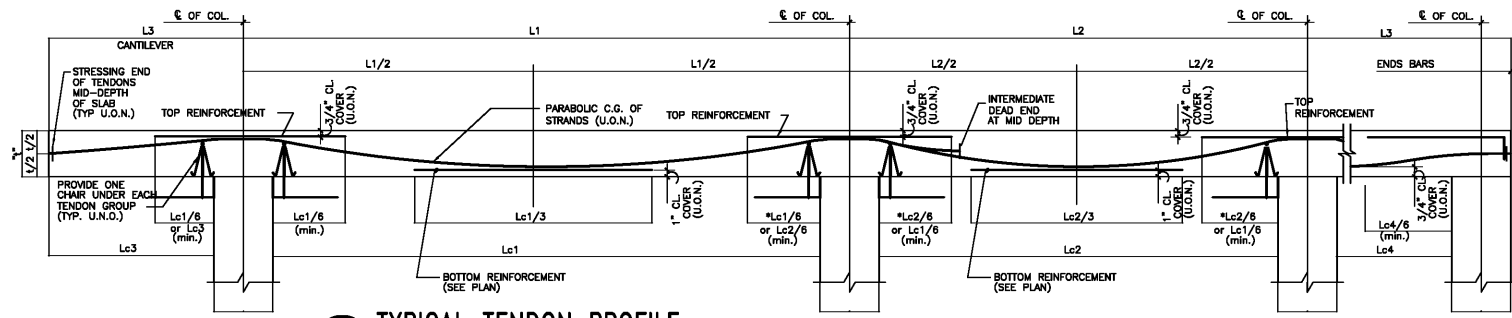
38 TYPICAL TENDON PROFILE
 NOTE: 1. WHEN THE LENGTH OF THE TOP REINFORCEMENT IS NOT INDICATED ON PLAN TAKE TOTAL LENGTH, AS INDICATED IN DETAIL # N.T.S.

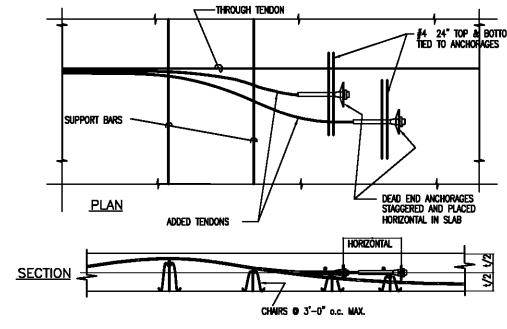
39 PLACEMENT OF ADDED TENDON IN CORROSIVE ENVIRONMENT
 N.T.S.

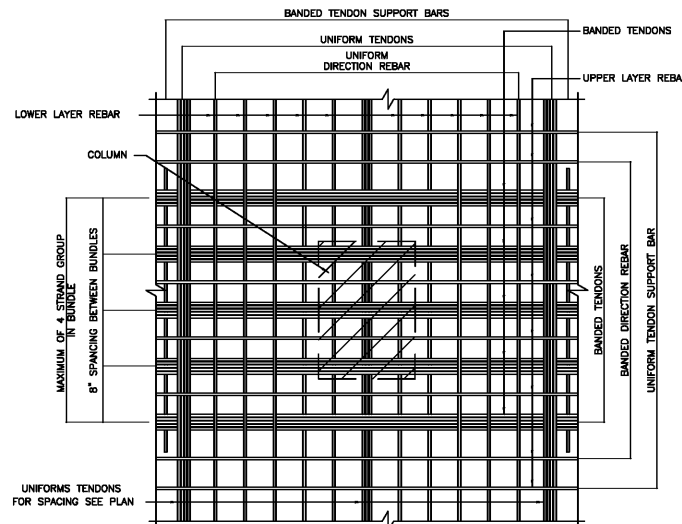
41 PLAN VIEW AT COLUMN
 UNIFORM TENDONS AT COLUMN CENTERLINE-TIED UNDER BANDED TENDONS N.T.S.

PLACEMENT SEQUENCE:
 1- PLACE UNIFORMS TENDONS (INSIDE OF COLUMNS)
 2- LOWER LAYER BARS
 3- PLACE BANDED TENDONS W/ UPPER LAYER BARS
 4- PLACE UNIFORMS TENDONS (OUTSIDE OF COLUMNS) UNDER UPPER LAYER BARS AND OVER BANDED TENDONS.

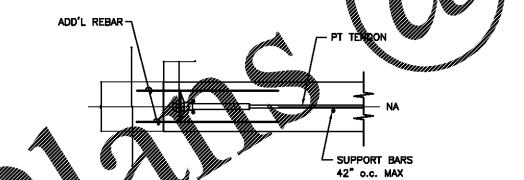
45 STRESSING END ANCHOR IN CORROSIVE ENVIRONMENT
 N.T.S.

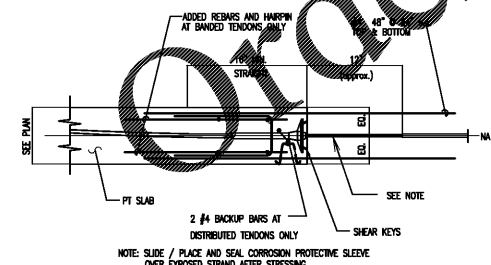
46 DEAD END IN CORROSIVE ENVIRONMENT
 N.T.S.

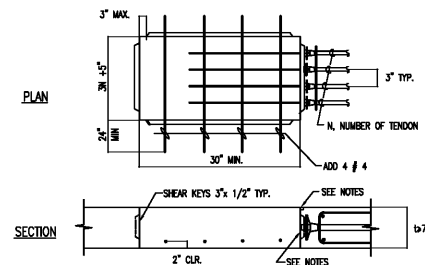
49 CONSTRUCTION JOINT WITH INTERMEDIATE STRESSING IN CORROSIVE ENVIRONMENT
 N.T.S.

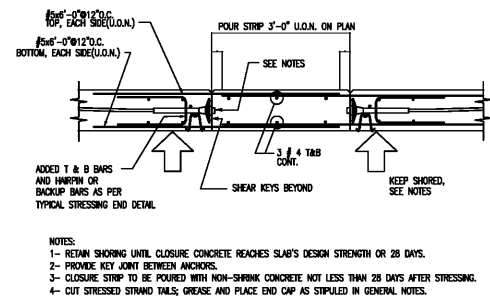
47 POUR STRIP IN SLAB FOR CORROSIVE ENVIRONMENT
 N.T.S.

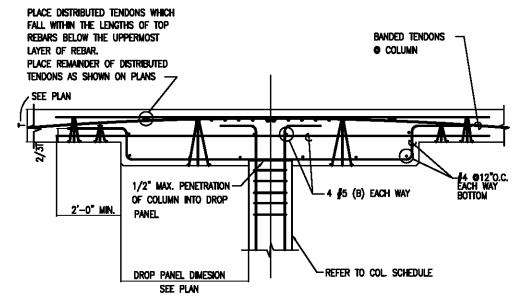
48 TYPICAL DROP PANEL SECTION
 N.T.S.

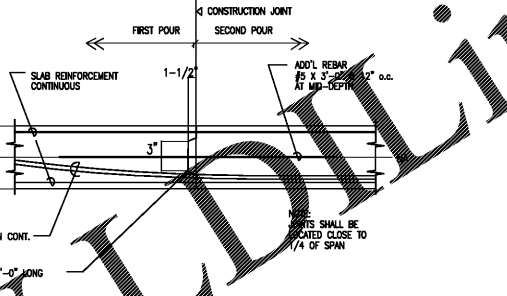
43 CONSTRUCTION JOINT WITH NO INTERMEDIATE STRESSING
 N.T.S.

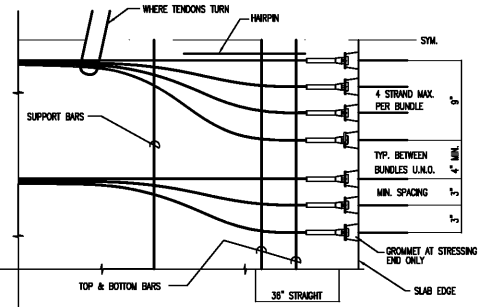
42 FLARING OF BANDED TENDONS AT SLAB EDGE IN CORROSIVE ENVIRONMENT
 N.T.S.

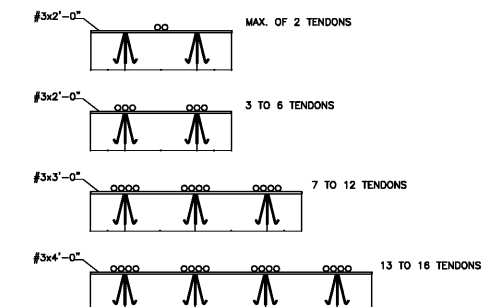
52 TYPICAL TENDON DISTRIBUTION AND SUPPORT DETAIL
 N.T.S.
