POPEYES
PLK 1930-28-DL SAILORMEN
501 N HWY 49
BIRTON, GA 31008

STRUCTURAL DETAILS

SHEET NO: S3

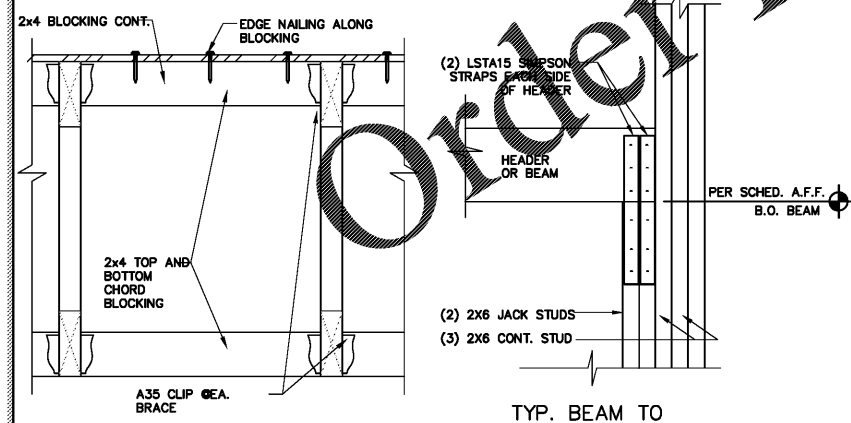
6 LATERAL BRACING DETAIL
1-1/2"-1'-0"

5 TYP. BEAM TO BEARING WALL CONN. @ LONG SPAN OPENINGS
1-1/2"-1'-0"
