SOUTH GREENVILLE
POINT REPAIR PROJECT

POINT REPAIR 59 - 71

Apprvd:	
Date:	1-29-18
Chkd:	JLD
Drwn:	MBL
Scale:	1"=200'
Project Number:	16-4005
Sheet:	C-9

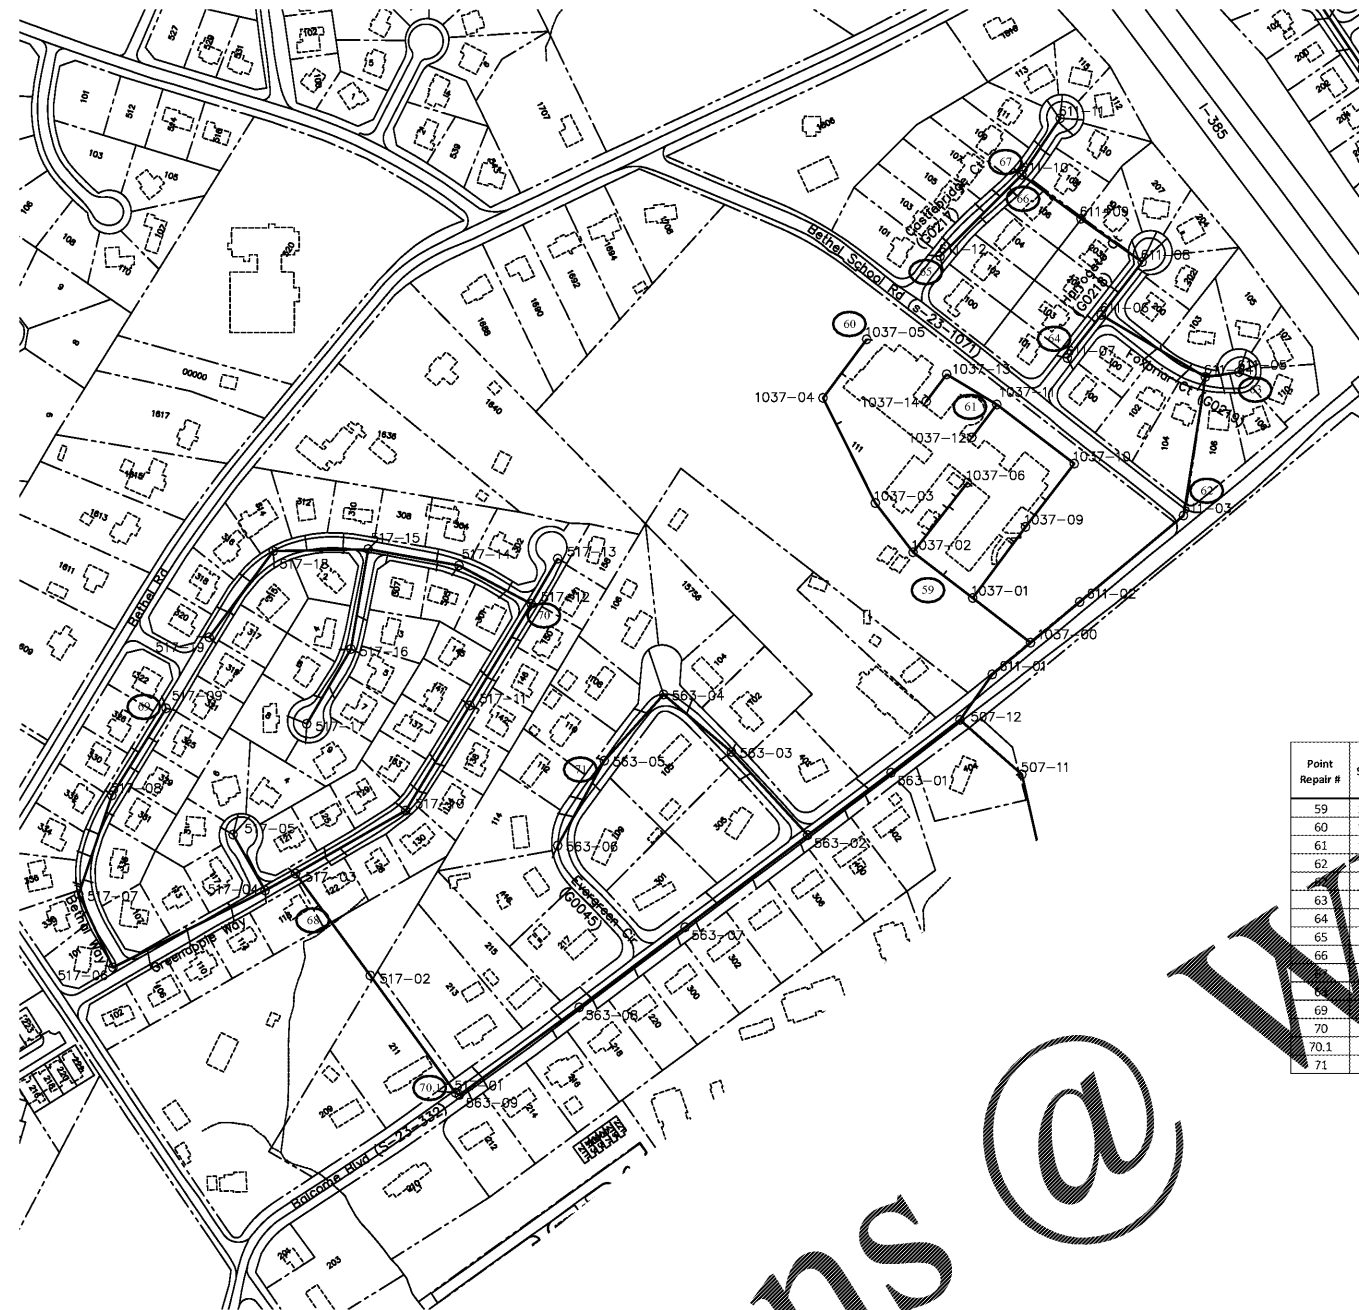
Point Repair #	Start MH	End MH	Start Depth (ft)	End MH Depth (ft)	Total Length of Pipe (ft)	Pipe Diameter (in)	Location Start (ft)	Pipe Material	Problem Summary	Service Position	Pre-CIPP	Repair	Repair Detail	Patch Detail
59	1037-02	1037-01	4.0	4.3	162.2	8	88.5	PVC	Service - Deformed Lateral	10		Pt. Repair (83.5 FT to 93.5 FT) - Install Tee and Lateral	2, 3, & 7	
60	1037-05	1037-04	4.4	4.2	128.4	8	23.6	PVC	Hole - Void Visible			Pt. Repair (18.6 FT to 30.2 FT)	5	11
61	1037-13	1037-12	5.0	5.0	97.2	8	67.2	PVC	Offset Joint - Small			Pt. Repair (62.2 FT to 72.2 FT)	5	
62	611-03	611-03	5.7	5.7	313.2	8	287.3	PVC	Offset Joint - Large			Pt. Repair (282.3 FT to 296.4 FT)	5	
63	611-04	611-03	6.3	5.7	313.2	8	291.4	PVC	Offset Joint - Large			Pt. Repair (282.3 FT to 296.4 FT)	5	
64	611-05	611-10	5.2	-	42.9	6	5.0	PVC	Hole - Void Visible			Replace to ROW	15	10
65	611-07	611-12	5.6	8.0	115.7	8	18.4	PVC	Service - Roots in Lateral	9		Pt. Repair (13.4 FT to 23.4 FT) - Install Tee and Lateral	2, 3, & 7	10

66	611-12	SERV 2	6.6	-	33.6	6	5.0	PVC	Roots at 1 Joint			Replace to ROW	15	10
67	611-12	611-10	6.6	8.0	277.4	8	220.5	PVC	Service - Roots in Lateral	3		Pt. Repair (215.5 FT to 225.5 FT) - Install Tee and Lateral	2, 3, & 7	10
68	611-10	SERV 11	8.0	-	27.8	6	5.0	PVC	Roots at 1 Joint			Replace to ROW	15	10
69	617-09	617-02	6.7	5.4	300.1	8	88.6	PVC	Service - Roots in Lateral	2		Pt. Repair (83.6 FT to 93.6 FT) - Install Tee and Lateral	2, 3, & 7	10
70	617-09	SERV 2	8.7	-	233.4	6	5.0	PVC	4 x 6 Connection - Roots at Connection	2		Replace to ROW	15	10

70.1	617-12	SERV 2	7.6	-	39.9	6	5.0	PVC	Roots at 1 Joint	2		Replace to ROW	15	10
71	517-01	SERV 11	5.1	-	15.1	6	15.1	PVC	4" Diameter Lateral			Replace to ROW	15	14
71	563-06	563-05	5.8	4.3	221.7	8	201.1	VCP	Offset Joint - Medium			Pt. Repair (196.1 FT to 206.1 FT)	5	10

NOTE:
SERVICE LATERALS ARE SHOWN FOR INFORMATION PURPOSES ARE APPROXIMATELY BASED ON CCTV DATA AND MANHOLE INSPECTIONS. NOT ALL EXISTING SERVICES ARE SHOWN. ALL SERVICES TO BE REPAIRED ARE SHOWN.
