SOUTH GREENVILLE
POINT REPAIR PROJECT
POINT REPAIR 86 - 110

PROJECT:	
SHEET TITLE:	
MARK:	DATE DESCRIPTION
Apprvd:	
Date:	1-29-18
Chkd:	JLD
Drawn:	MBL
Scale:	1"=200'
Project Number:	16-4005
Sheet:	C-11

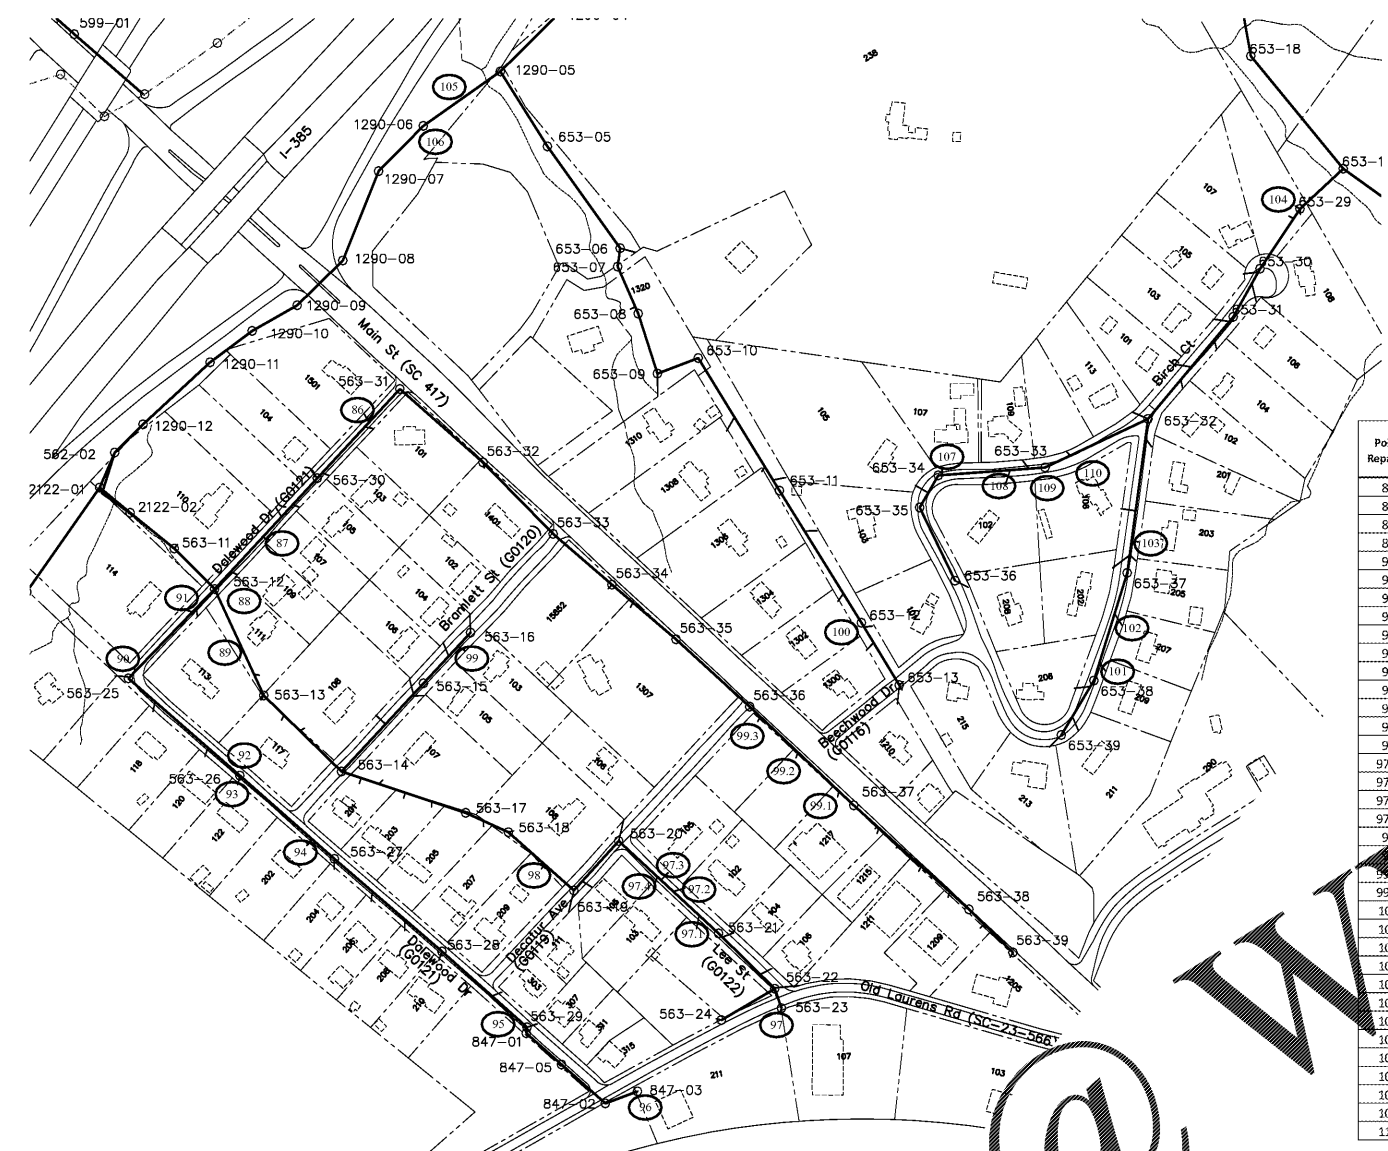
NOTE:
SERVICE LATERALS ARE SHOWN FOR INFORMATION PURPOSES ARE APPROXIMATELY BASED ON CCTV DATA AND MANHOLE INSPECTIONS. NOT ALL EXISTING SERVICES ARE SHOWN. ALL SERVICES TO BE REPAIRED ARE SHOWN.
