Approved: *[Signature]*
Date: 1-29-18
Checked: JLD
Drawn: MBL
Scale: 1"=200'
Project Number: 16-4005
Sheet: C-12

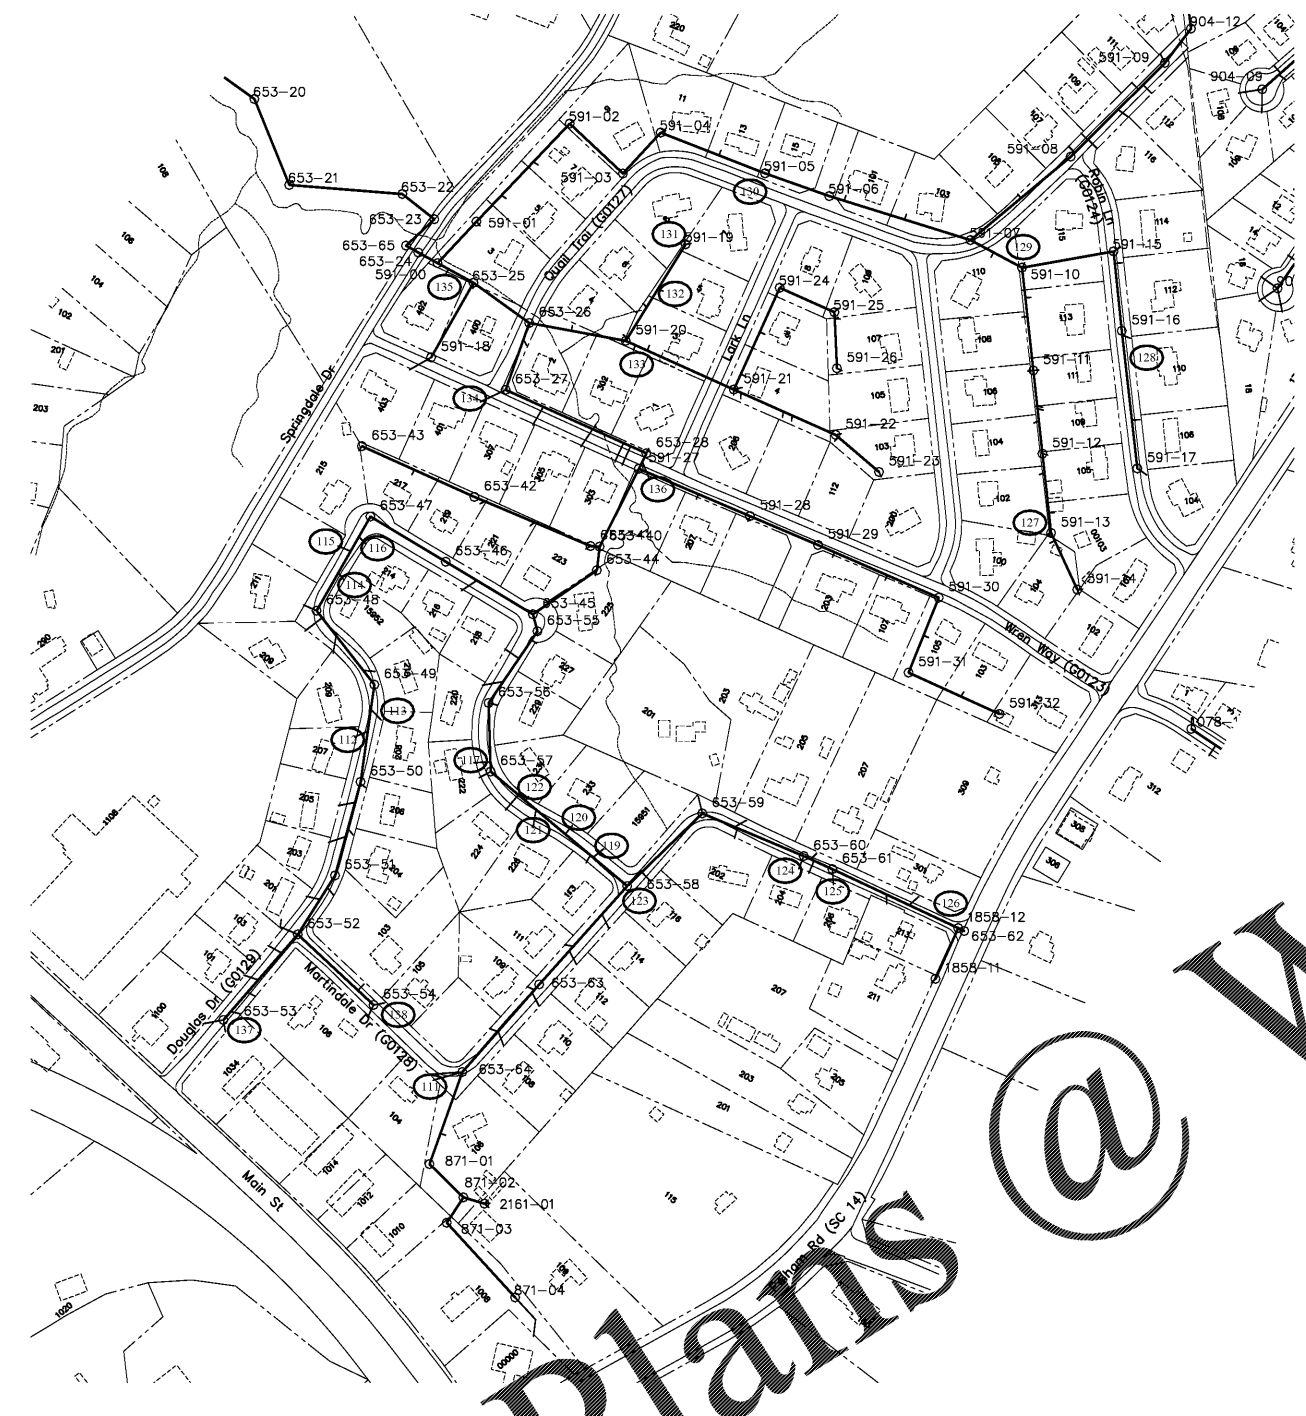
NOTE:
SERVICE LATERALS ARE SHOWN FOR INFORMATION PURPOSES ARE APPROXIMATELY BASED ON CCTV DATA AND MANHOLE INSPECTIONS. NOT ALL EXISTING SERVICES ARE SHOWN. ALL SERVICES TO BE REPAIRED ARE SHOWN.
