FAULT CURRENT CALCULATIONS

ONE LINE DIAGRAM

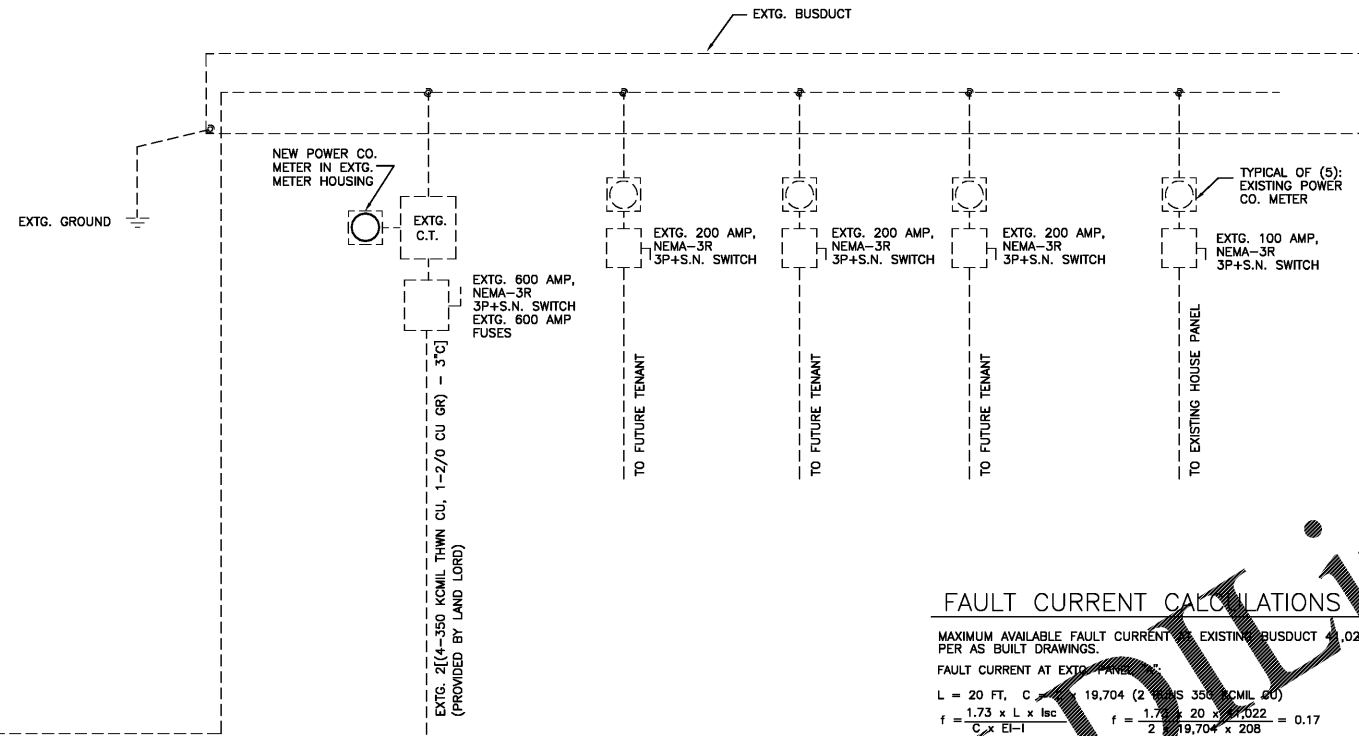
MAXIMUM AVAILABLE FAULT CURRENT - EXISTING BUSDUCT 41,022 AMP RMS. PER AS BUILT DRAWINGS.

FAULT CURRENT AT EXISTING PANEL "A":
 $L = 20 \text{ FT.}, C = 19,704 (2 \text{ RUNS } 35\text{K CMIL } \#0)$
 $f = \frac{1.73 \times L \times I_{sc}}{C \times EI - 1} = \frac{1.73 \times 20 \times 41,022}{19,704 \times 208} = 0.17$
 $m = \frac{1}{1 + f} = \frac{1}{1 + 0.17} = 0.85$

$I_{sc} \text{ AT EXISTING PANEL "A"} = 41,022 \text{ AMP} \times 0.85 = 34,869 \text{ AMP}$
 ALL EXISTING CIRCUIT BREAKERS IN PANEL "A" SHALL BE SERIES RATED WITH 600 AMP FUSES IN MAIN DISCONNECT, OR FULLY RATED AND PROVIDED BY THE LANDLORD.

FAULT CURRENT AT NEW SUB PANELS "B":
 $L = 25 \text{ FT.}, C = 8,925 (1 \text{ RUN } 1/0 \text{ CU})$
 $f = \frac{1.73 \times L \times I_{sc}}{C \times EI - 1} = \frac{1.73 \times 25 \times 34,869}{8,925 \times 208} = 0.81$
 $m = \frac{1}{1 + f} = \frac{1}{1 + 0.81} = 0.55$

$I_{sc} \text{ AT NEW SUB PANELS "B"} = 34,869 \text{ AMP} \times 0.55 = 19,178 \text{ AMP}$
 ALL CIRCUIT BREAKERS IN NEW SUB PANELS "B" SHALL BE FULLY RATED 22,000 A.I.C.

FAULT CURRENT AT NEW SUB PANELS "C":
 $L = 30 \text{ FT.}, C = 8,925 (1 \text{ RUN } 1/0 \text{ CU})$
 $f = \frac{1.73 \times L \times I_{sc}}{C \times EI - 1} = \frac{1.73 \times 30 \times 34,869}{8,925 \times 208} = 0.97$
 $m = \frac{1}{1 + f} = \frac{1}{1 + 0.97} = 0.51$

$I_{sc} \text{ AT NEW SUB PANELS "C"} = 34,869 \text{ AMP} \times 0.51 = 17,783 \text{ AMP}$
 ALL CIRCUIT BREAKERS IN NEW SUB PANELS "C" SHALL BE FULLY RATED 22,000 A.I.C.

FAULT CURRENT AT NEW SUB PANELS "D":
 $L = 35 \text{ FT.}, C = 8,925 (1 \text{ RUN } 1/0 \text{ CU})$
 $f = \frac{1.73 \times L \times I_{sc}}{C \times EI - 1} = \frac{1.73 \times 35 \times 34,869}{8,925 \times 208} = 1.14$
 $m = \frac{1}{1 + f} = \frac{1}{1 + 1.14} = 0.47$

$I_{sc} \text{ AT NEW SUB PANELS "D"} = 34,869 \text{ AMP} \times 0.47 = 16,388 \text{ AMP}$
 ALL CIRCUIT BREAKERS IN NEW SUB PANELS "D" SHALL BE FULLY RATED 22,000 A.I.C.

FAULT CURRENT AT NEW DIMMING SYSTEM PANEL "DP":
 $L = 60 \text{ FT.}, C = 981 (1 \text{ RUN } \#10 \text{ CU})$
 $f = \frac{1.73 \times L \times I_{sc}}{C \times EI - 1} = \frac{1.73 \times 60 \times 34,869}{981 \times 208} = 17.74$
 $m = \frac{1}{1 + f} = \frac{1}{1 + 17.74} = 0.053$

$I_{sc} \text{ AT NEW DIMMING SYSTEM "DP"} = 34,869 \text{ AMP} \times 0.053 = 1,848 \text{ AMP}$
 ALL CIRCUIT BREAKERS IN NEW DIMMING SYSTEM "DP" SHALL BE FULLY RATED 10,000 A.I.C.

FAULT CURRENT AT NEW RELAY CONTROL PANEL "RP":
 $L = 60 \text{ FT.}, C = 2,425 (1 \text{ RUN } \#6 \text{ CU})$
 $f = \frac{1.73 \times L \times I_{sc}}{C \times EI - 1} = \frac{1.73 \times 60 \times 34,869}{2,425 \times 208} = 7.18$
 $m = \frac{1}{1 + f} = \frac{1}{1 + 7.18} = 0.12$

$I_{sc} \text{ AT NEW RELAY CONTROL PANEL "RP"} = 34,869 \text{ AMP} \times 0.12 = 4,184 \text{ AMP}$
 ALL CIRCUIT BREAKERS IN NEW RELAY CONTROL PANEL "RP" SHALL BE FULLY RATED 10,000 A.I.C.

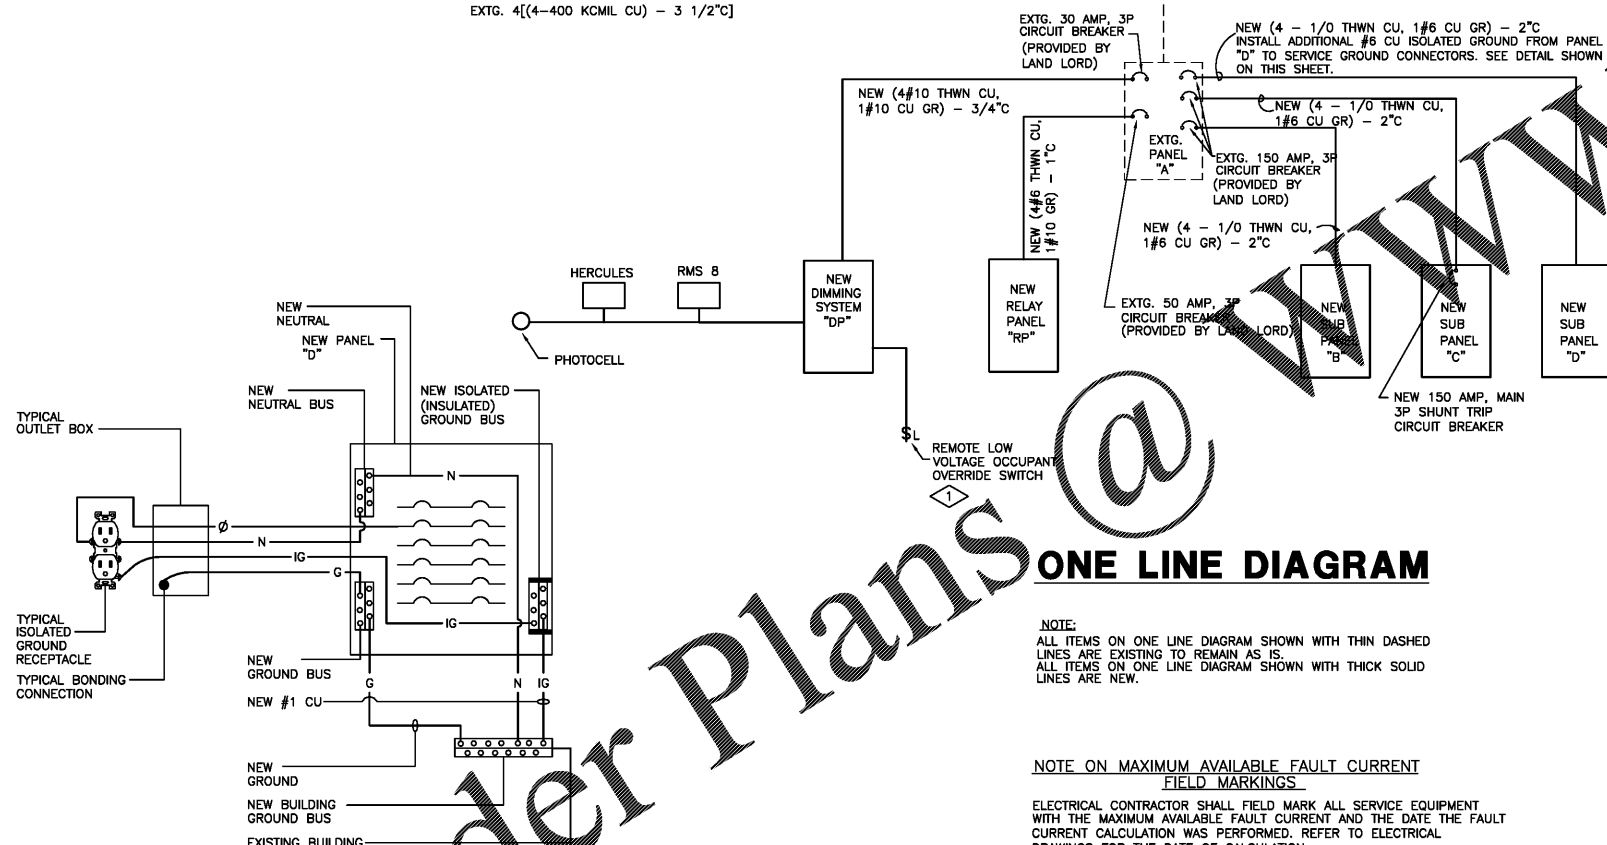
NOTE:
 ALL ITEMS ON ONE LINE DIAGRAM SHOWN WITH THIN DASHED LINES ARE EXISTING TO REMAIN AS IS.
 ALL ITEMS ON ONE LINE DIAGRAM SHOWN WITH THICK SOLID LINES ARE NEW.
