**SOUTH GREENVILLE POINT REPAIR PROJECT**  
 POINT REPAIR 20 - 29

Approval:   
 Date: 1-29-2018  
 Checked: JLD  
 Drawn:  
 Scale: 1"=200'  
 Project Number: 16-4005  
 Sheet: C-5

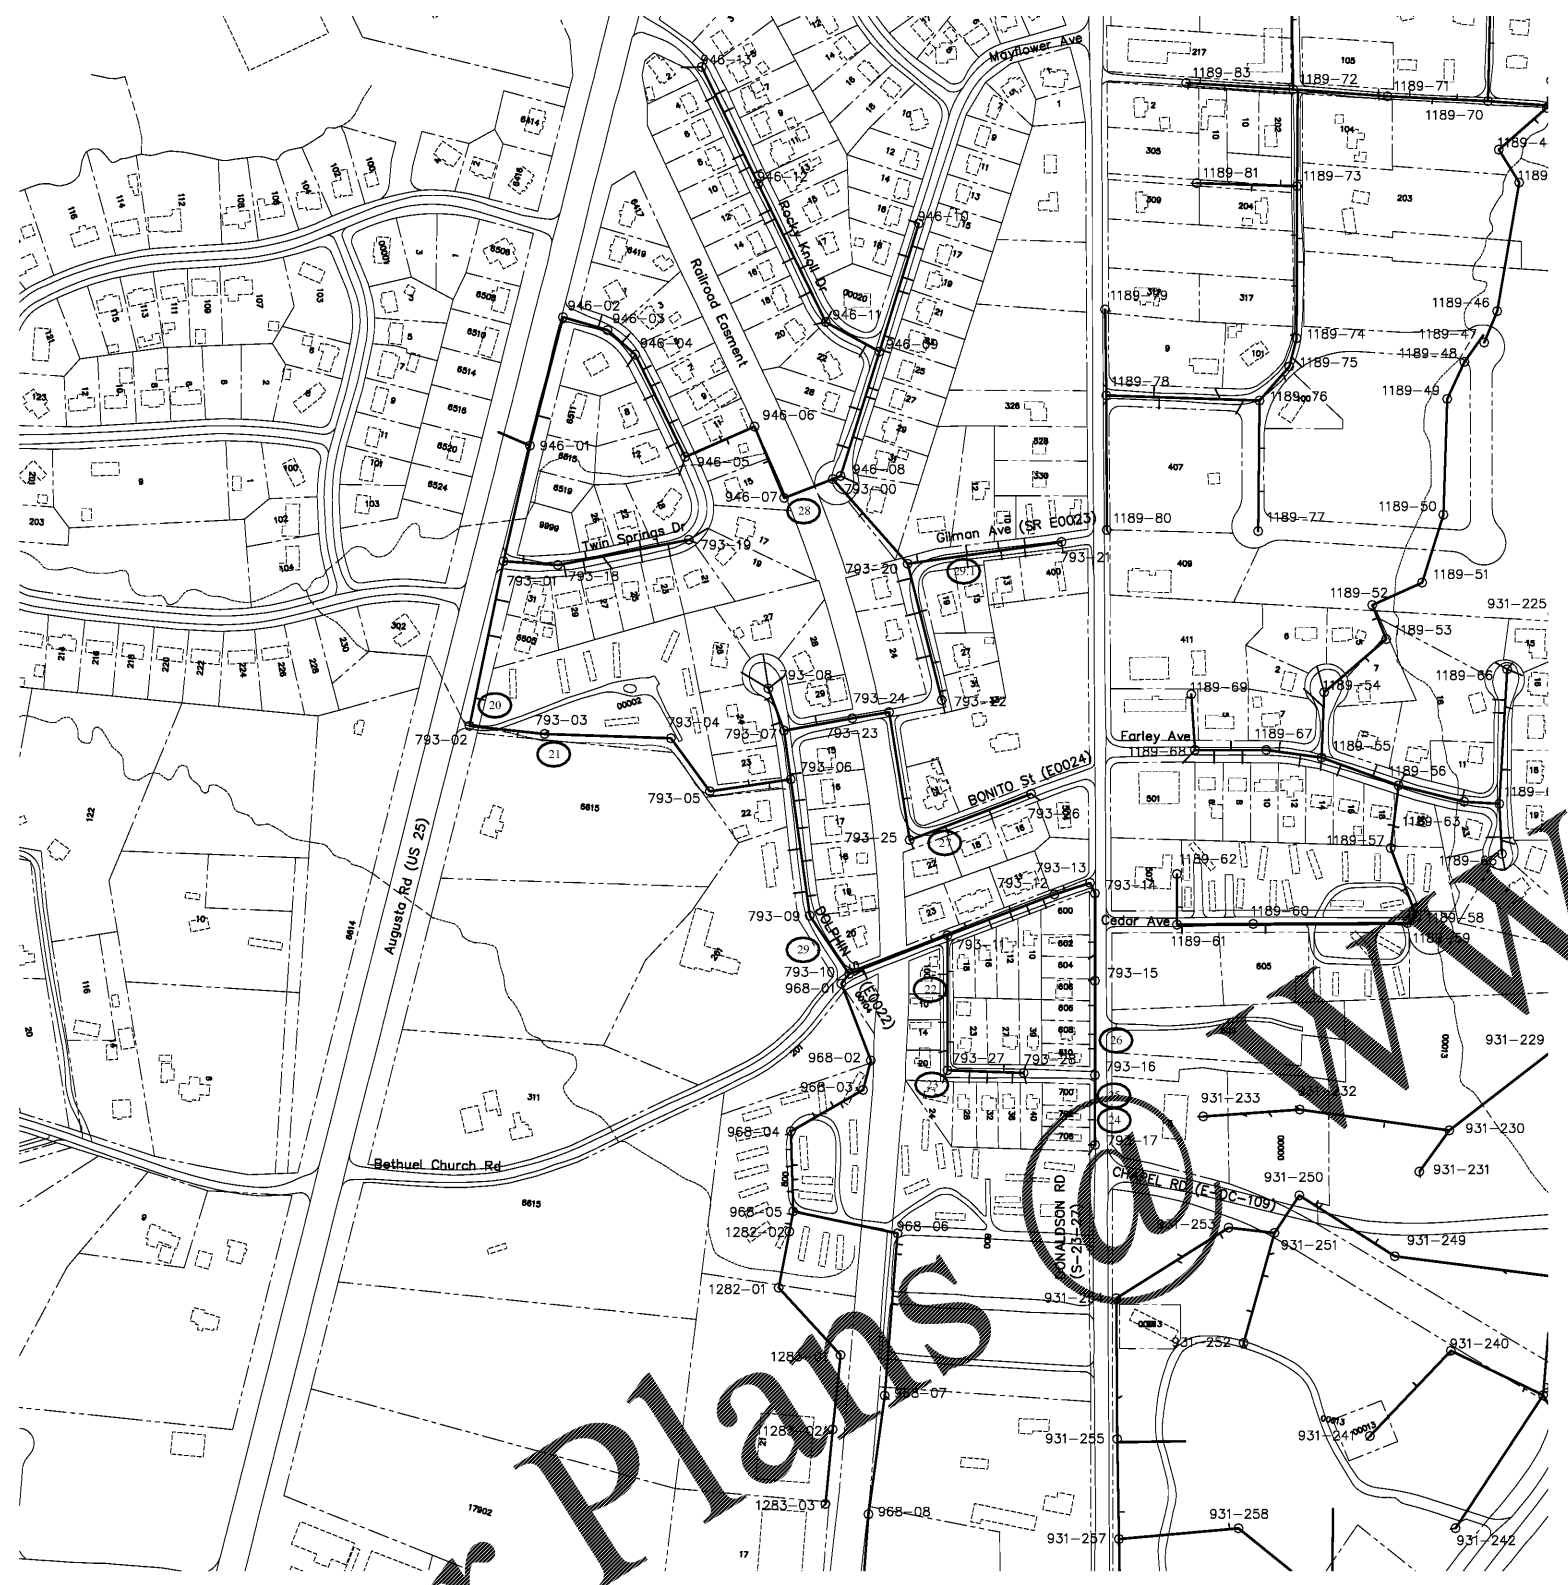
Point Repair #	Start MH	End MH	Start MH Depth (ft)	End MH Depth (ft)	Length of Pipe (ft)	Pipe Diameter (in)	Location from Start MH (ft)	Pipe Material	Problem Summary	Service Position	Pre-CIPP	Repair	Repair Detail	Patch Detail
20	793-02	793-01	4.1	4.3	385.0	8	66.4	VCP	Service - Roots at Tee and Lateral	3		Pt. Repair (61.4 FT to 71.4 FT) - Install Tee and Lateral	2, 3, & 7	
21	793-03	793-04	5.6	5.4	304.3	6	5.0	VCP	Roots in Lateral			Replace to ROW	15	
22	793-03	793-04	8.3	9.1	304.3	8	171.4	VCP	Service - Offset Joint in Lateral	9		Pt. Repair using DIP (166.4 FT to 176.4 FT) - Install Tee and Lateral	2, 3, & 7	10
23	793-04	793-05	8.3	8.3	24.1	6	5.0	VCP	Offset Joint - Small	1		Replace to ROW	15	10
24	793-16	793-17	5.2	5.5	147.5	8	103.1	VCP	Service - No Visible Defects	3	*	Pt. Repair (98.1 FT to 108.1 FT) - Install Tee and Lateral	2, 3, & 7	14
25	793-16	793-17	5.5	5.5	147.5	8	62.4	VCP	Service - Capped	3	*	Pt. Repair (57.4 FT to 67.4 FT) - Install Tee and Lateral	2, 3, & 7	14

26	793-16	793-15	5.2	5.0	220.2	8	96.9	VCP	Service - Offset at 4 x 6	9		Pt. Repair (91.9 FT to 101.9 FT) - Install Tee and Lateral	2, 3, & 7	14
27	793-26	793-25	8.2	7.8	295.1	8	209.8	VCP	Service - Roots at Tee and Lateral	9		Pt. Repair (204.8 FT to 214.8 FT) - Install Tee and Lateral	2, 3, & 7	10
28	793-10	793-09	13.2	8.0	166.0	8	93.0	VCP	Service - Roots at Tee and Lateral	3		Pt. Repair (88.0 FT to 98.0 FT) - Install Tee and Lateral	2, 3, & 7	14
29	793-20	793-20	5.8	4.7	356.4	8	222.9	VCP	Service - Roots at Tee and Lateral	9		Pt. Repair (217.9 FT to 227.9 FT) - Install Tee and Lateral	2, 3, & 7	10

NOTE:  
 SERVICE LATERALS ARE SHOWN FOR INFORMATION PURPOSES ARE APPROXIMATELY BASED ON CCTV DATA AND MANHOLE INSPECTIONS. NOT ALL EXISTING SERVICES ARE SHOWN. ALL SERVICES TO BE REPAIRED ARE SHOWN.
