Proj. No.: 078761
 Date: 11/02/2018

Sheet Name:
 ADA REFERENCE
 DETAILS

G1.2

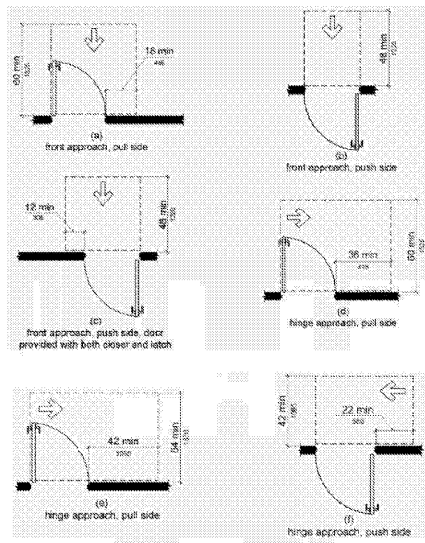
Figure 404.2.4.1
 Maneuvering Clearances at Manual Swinging Doors and Gates
