DATE	ISSUE	BY
18220	Job Number	ZZ
	Drawn	ZZ
	Checked	SG
	Approved	JH

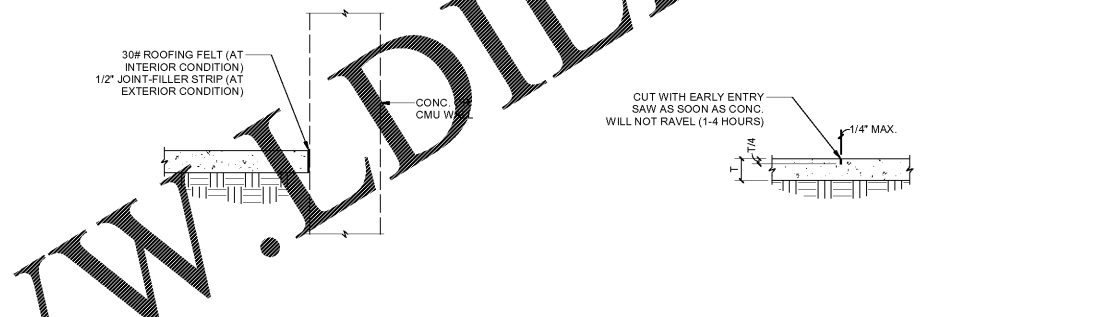
6 TYPICAL SLAB-ON-GROUND BUTT JOINT  
S01-01

7 TYPICAL SLAB-ON-GROUND CONTRACTION JOINT  
S01-01
