Norton Commons North - Apartments
 Prospect, Kentucky

STRUCTURAL
 STANDARD
 POST TENSION
 DETAILS

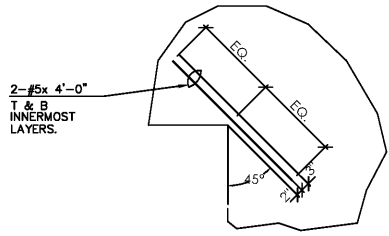
30 TYPICAL RE-ENTRANT CORNER DETAIL N.T.S.
