CONSTRUCTION STAGING PLAN

**1-85 @ SR 18 & SR 18 @ SR 103
 STAGE 3 TRAFFIC SIGNAL**

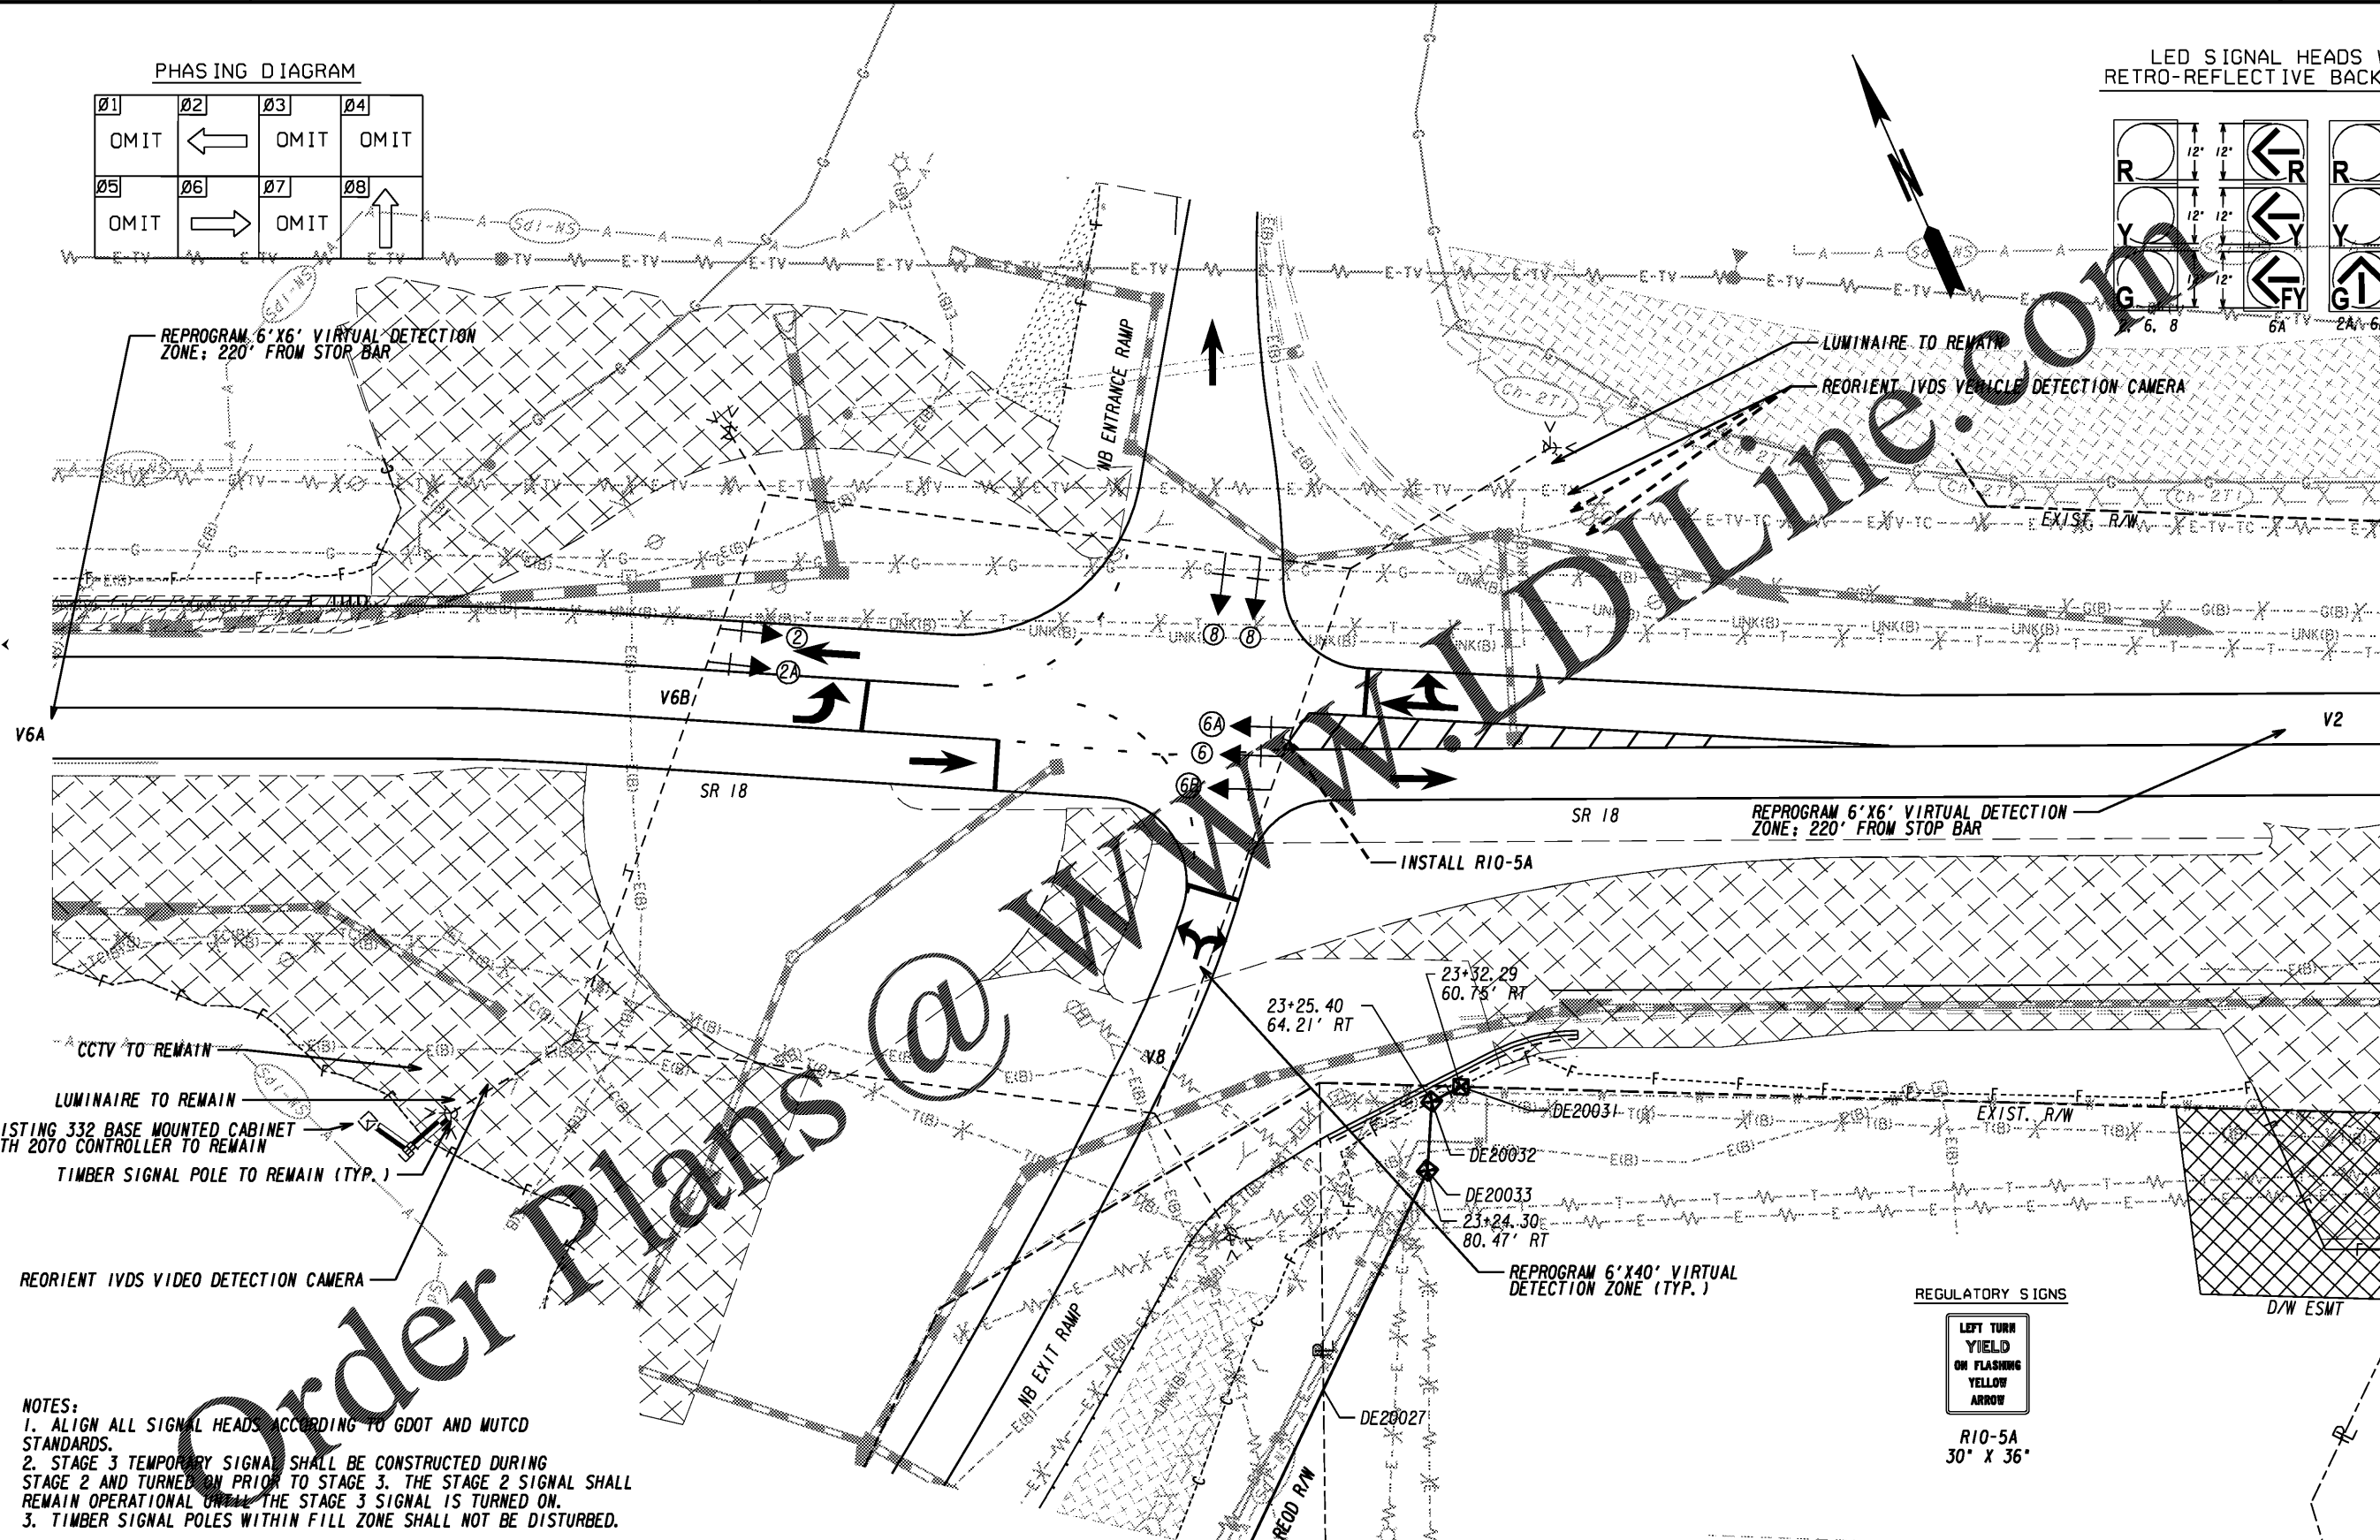
LED SIGNAL HEADS WITH RETRO-REFLECTIVE BACK PLATES

CCTV TO REMAIN
 LUMINAIRE TO REMAIN
 EXISTING 332 BASE MOUNTED CABINET WITH 2070 CONTROLLER TO REMAIN
 TIMBER SIGNAL POLE TO REMAIN (TYP.)
