| DRAINAGE AREA MAP | | | |
| I-85 @ SR 18 & SR 18 @ SR 103 | | | |
| BACKCHECKED: | DATE: | 21-0007 | |

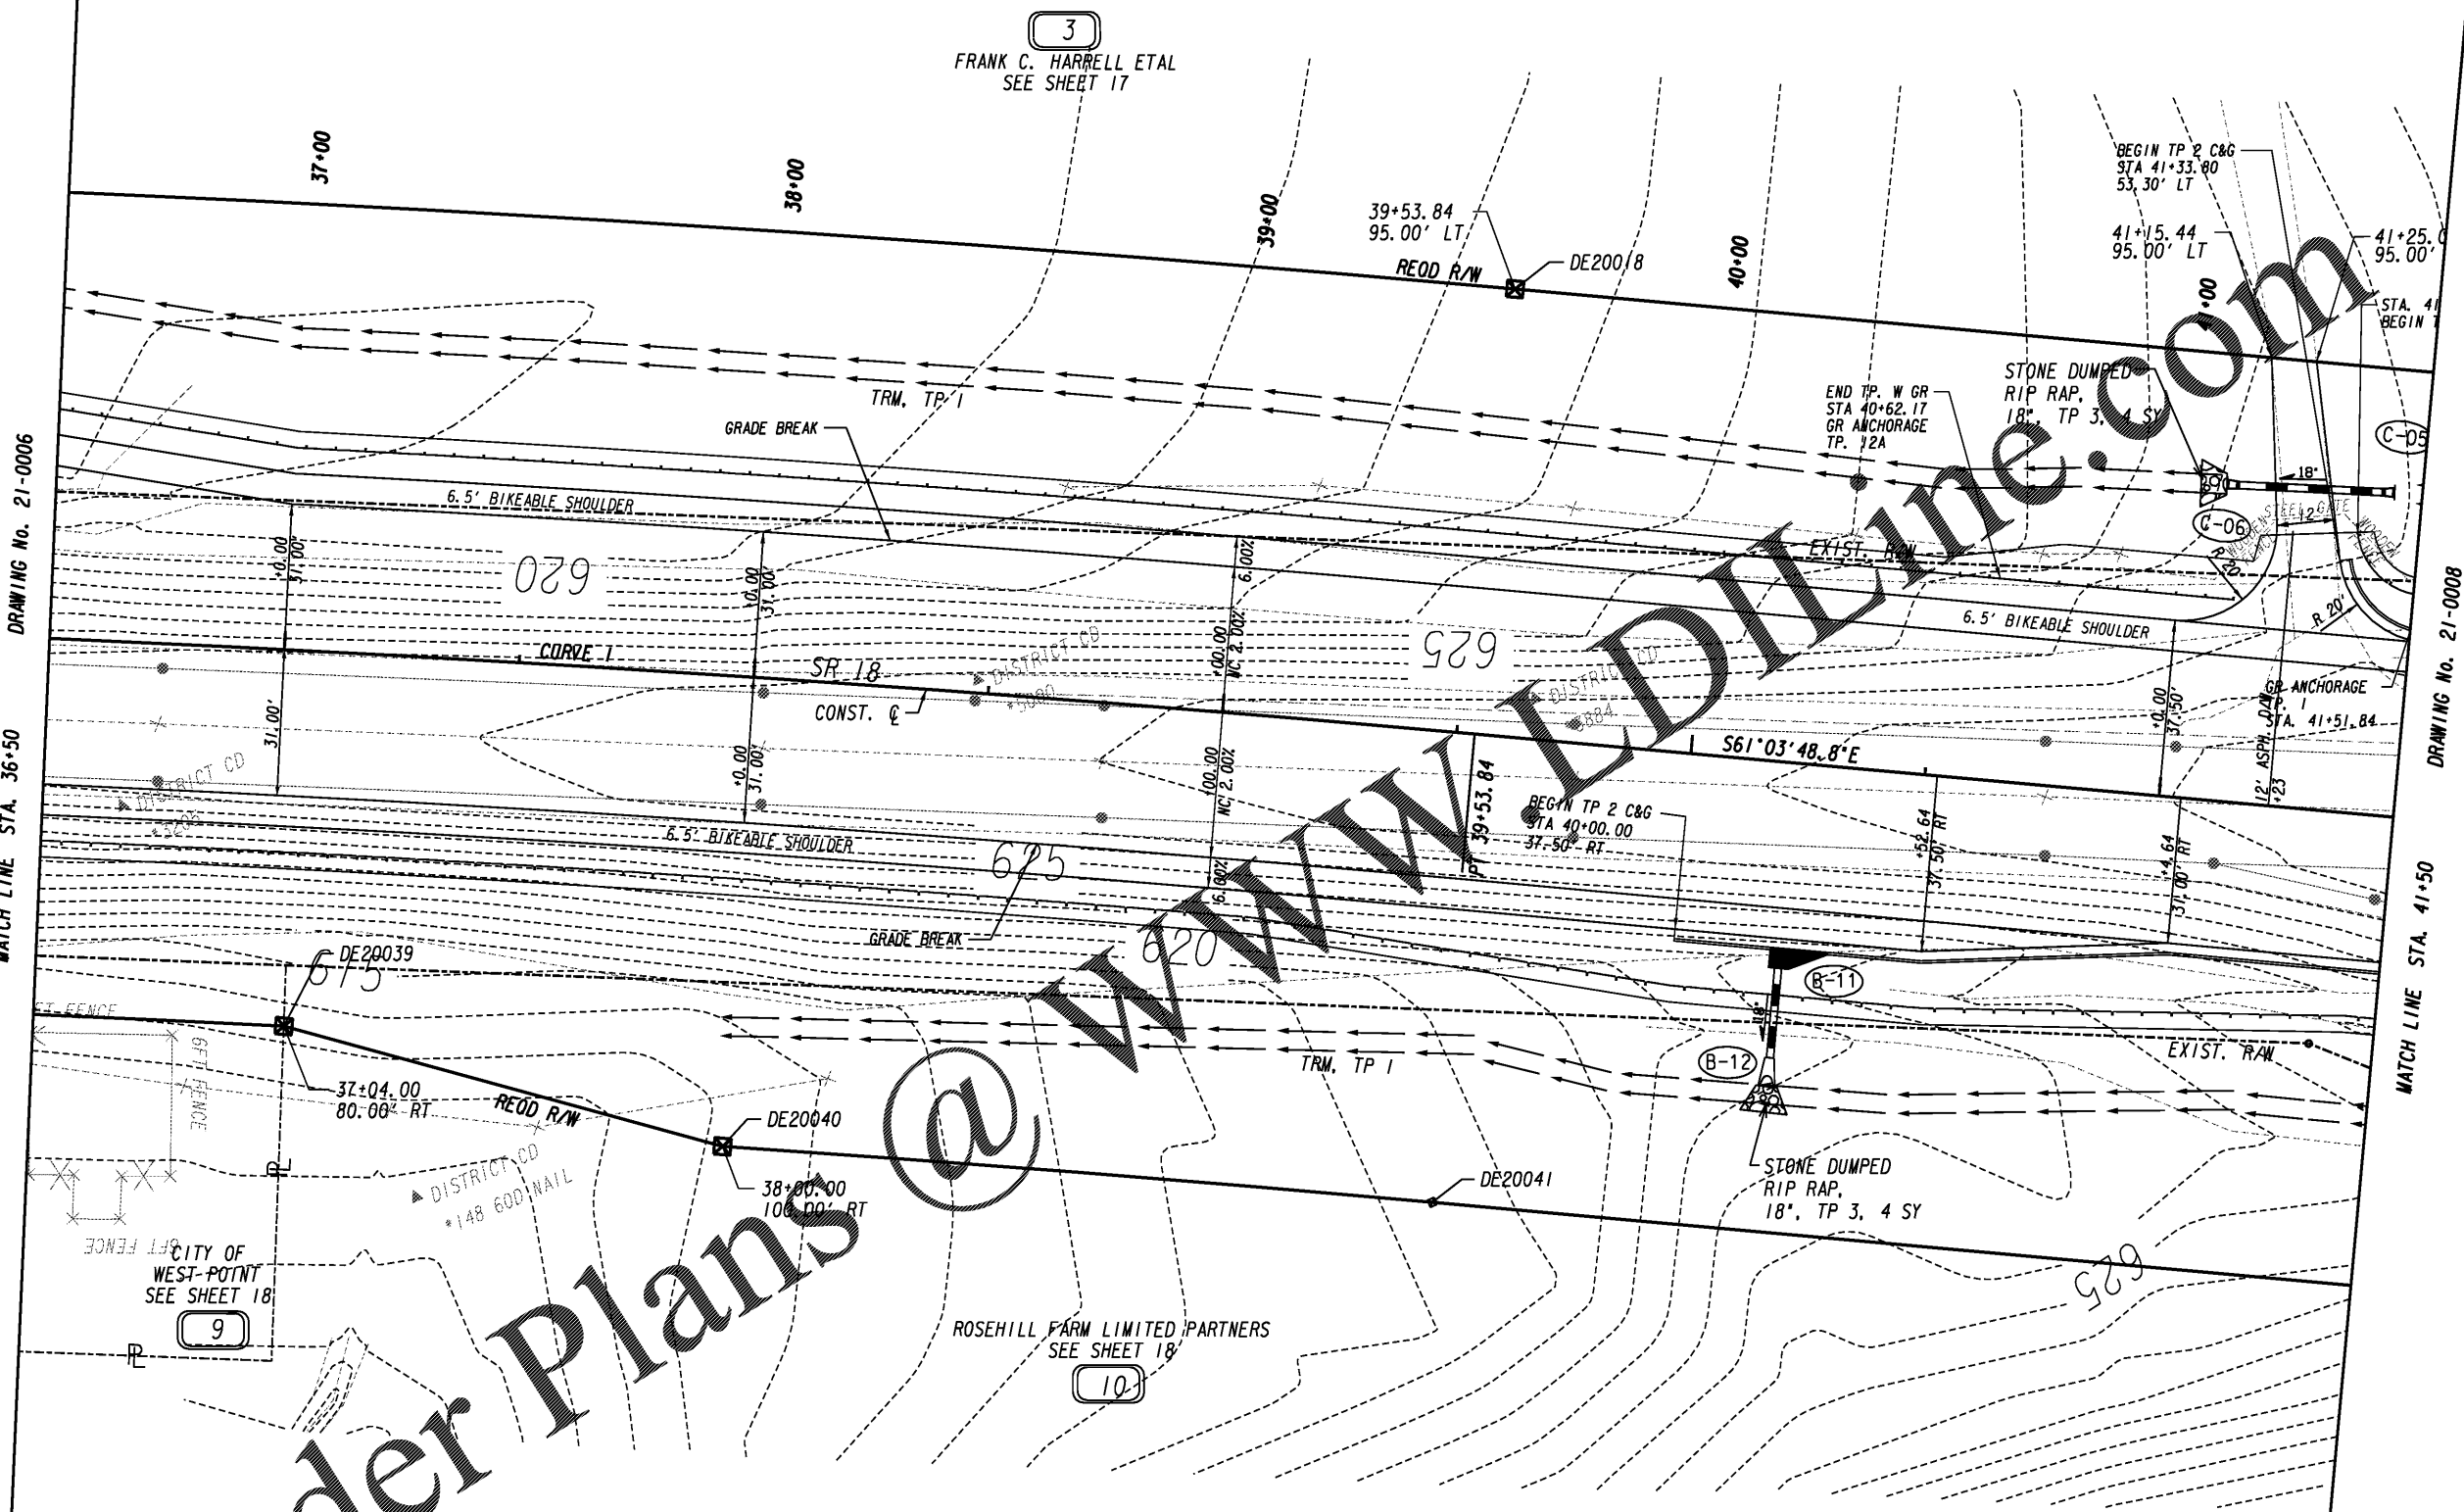
| Structure | | Location | | | | Drainage Area | Q10 | | | Disturbed Area | Receiving Water |
|---|---|---|---|---|---|---|---|---|---|---|---|
| B-11 | 1033D | SR 18 | 40+25 | 20.50 | RT | 0.15 | 0.95 | 1.52 | 5.00 | 0.15 | Long Cane Creek |
