INTERMEDIATE PHASE		
BMP LOCATION DETAILS		
SR 18 BRIDGE REPLACEMENT @ LONG CAME CREEK		
TROUP COUNTY		
STAGE 3 STA 101+92.00 TO STA 104+50.00		
CHECKED:	DATE:	DRAWING No.
BACKCHECKED:	DATE:	54-0010
CORRECTED:	DATE:	
VERIFIED:	DATE:

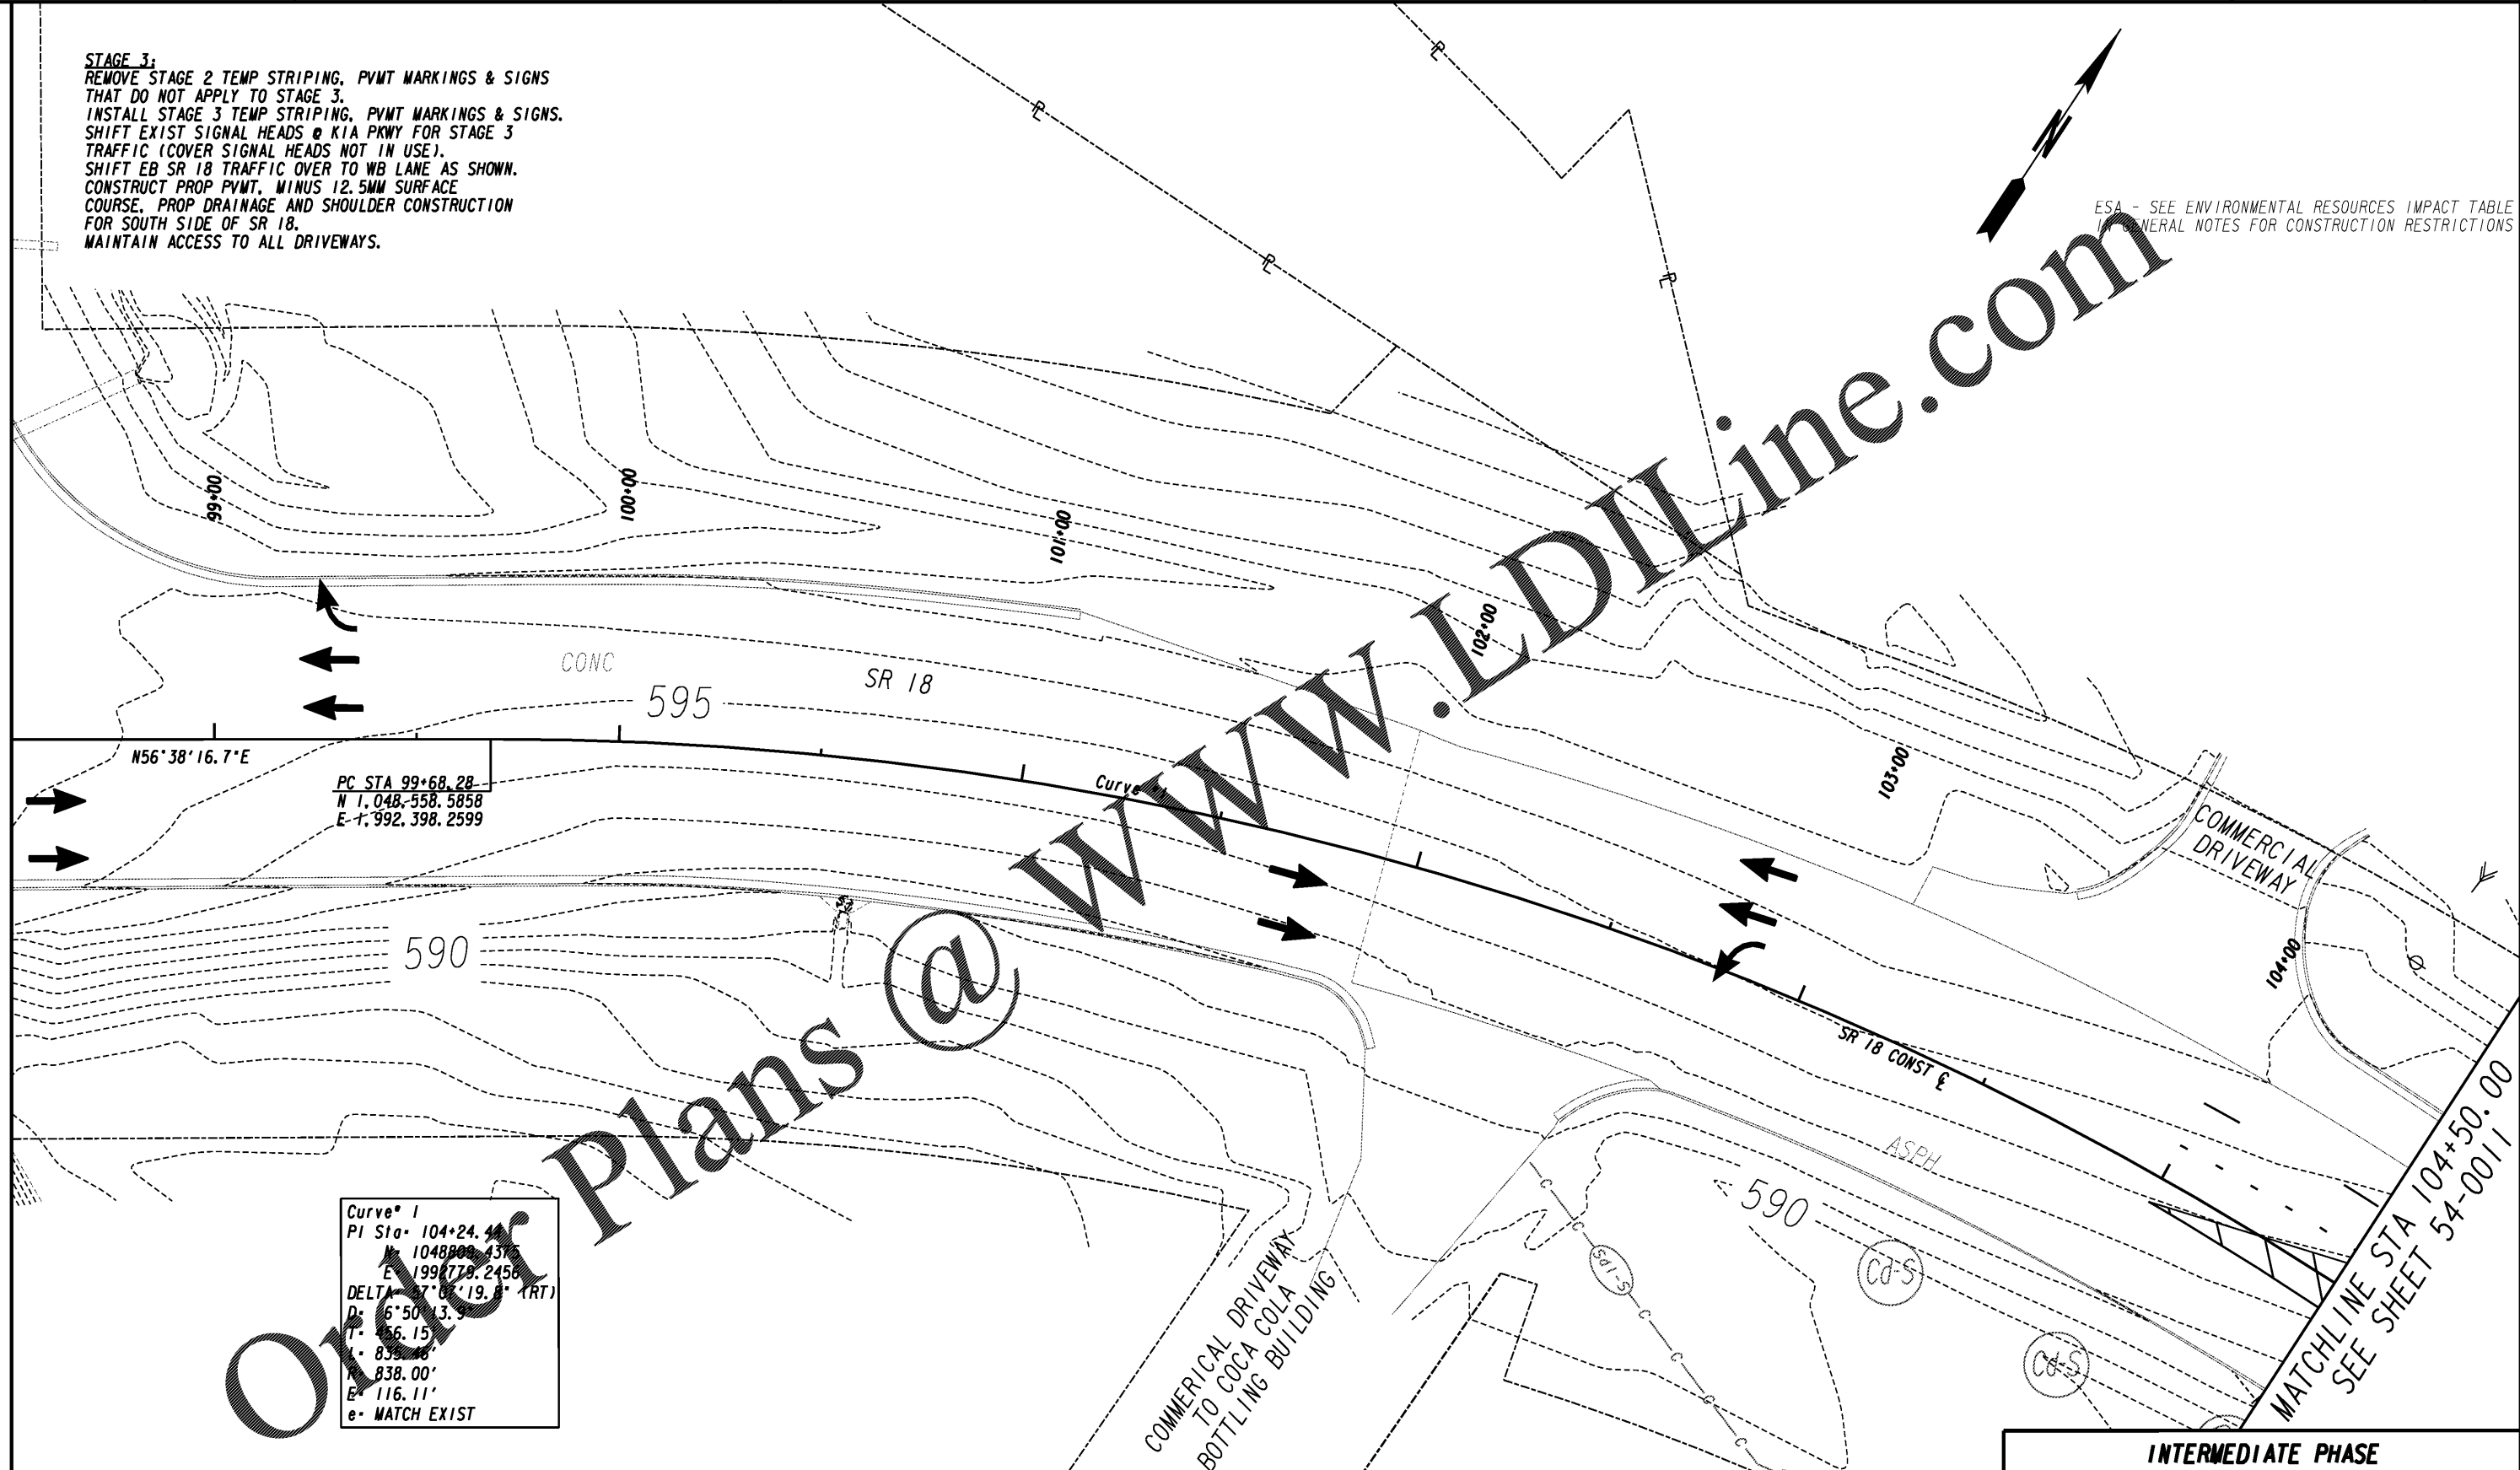
STAGE 3:
 REMOVE STAGE 2 TEMP STRIPING, PVMT MARKINGS & SIGNS THAT DO NOT APPLY TO STAGE 3.
 INSTALL STAGE 3 TEMP STRIPING, PVMT MARKINGS & SIGNS. SHIFT EXIST SIGNAL HEADS @ KIA PKWY FOR STAGE 3 TRAFFIC (COVER SIGNAL HEADS NOT IN USE).
 SHIFT EB SR 18 TRAFFIC OVER TO WB LANE AS SHOWN. CONSTRUCT PROP PVMT, MINUS 12.5MM SURFACE COURSE, PROP DRAINAGE AND SHOULDER CONSTRUCTION FOR SOUTH SIDE OF SR 18.
 MAINTAIN ACCESS TO ALL DRIVEWAYS.

Curve 1

PI Sta	104+24.41
N	1048800.437
E	1998778.2458
DELTA	7°07'19.8" (RT)
D	6°50'13.5"
L	56.15'
e	839.28'
e	838.00'
e	116.11'
e	MATCH EXIST
